— HOW TO ADJUST —

LWZ-1 ZONE LOCKING DEVICE NEW INSTALLATION	
				SCALE 1/4	DATE 5-31-94
				DWG. BY	M7410
No.	REVISION	DATE	CHK.	CHK. BY

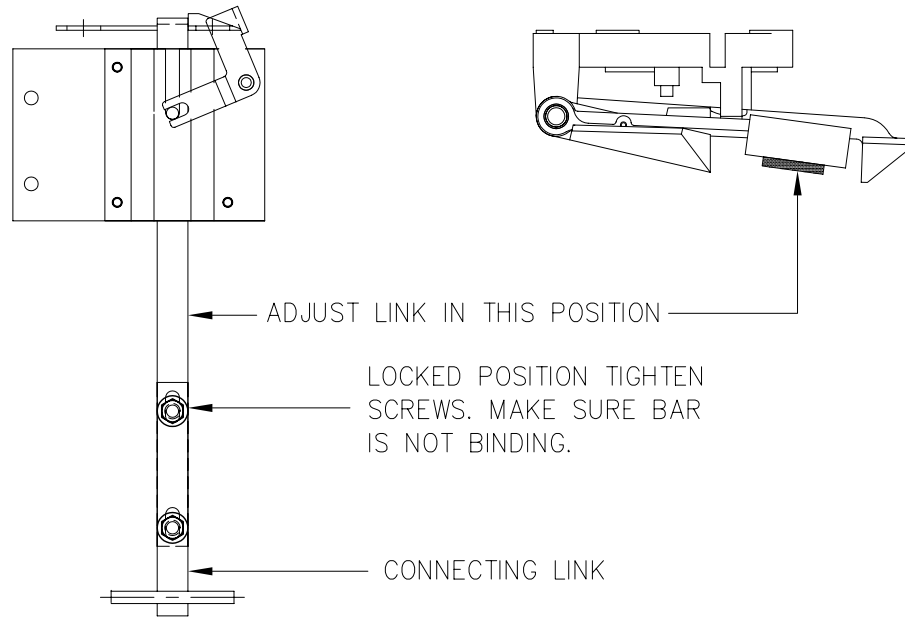
①

CAR DOOR LOCKED
NO INTERLOCK ROLLERS PRESENT
